historic structure report
architectural data section
phase II: exterior preservation

JEFFERSON NATIONAL EXPANSION MEMORIAL
OLD COURTHOUSE

HISTORIC STRUCTURE REPORT
Architectural Data Section
Phase II: Exterior Preservation

by
David G. Henderson

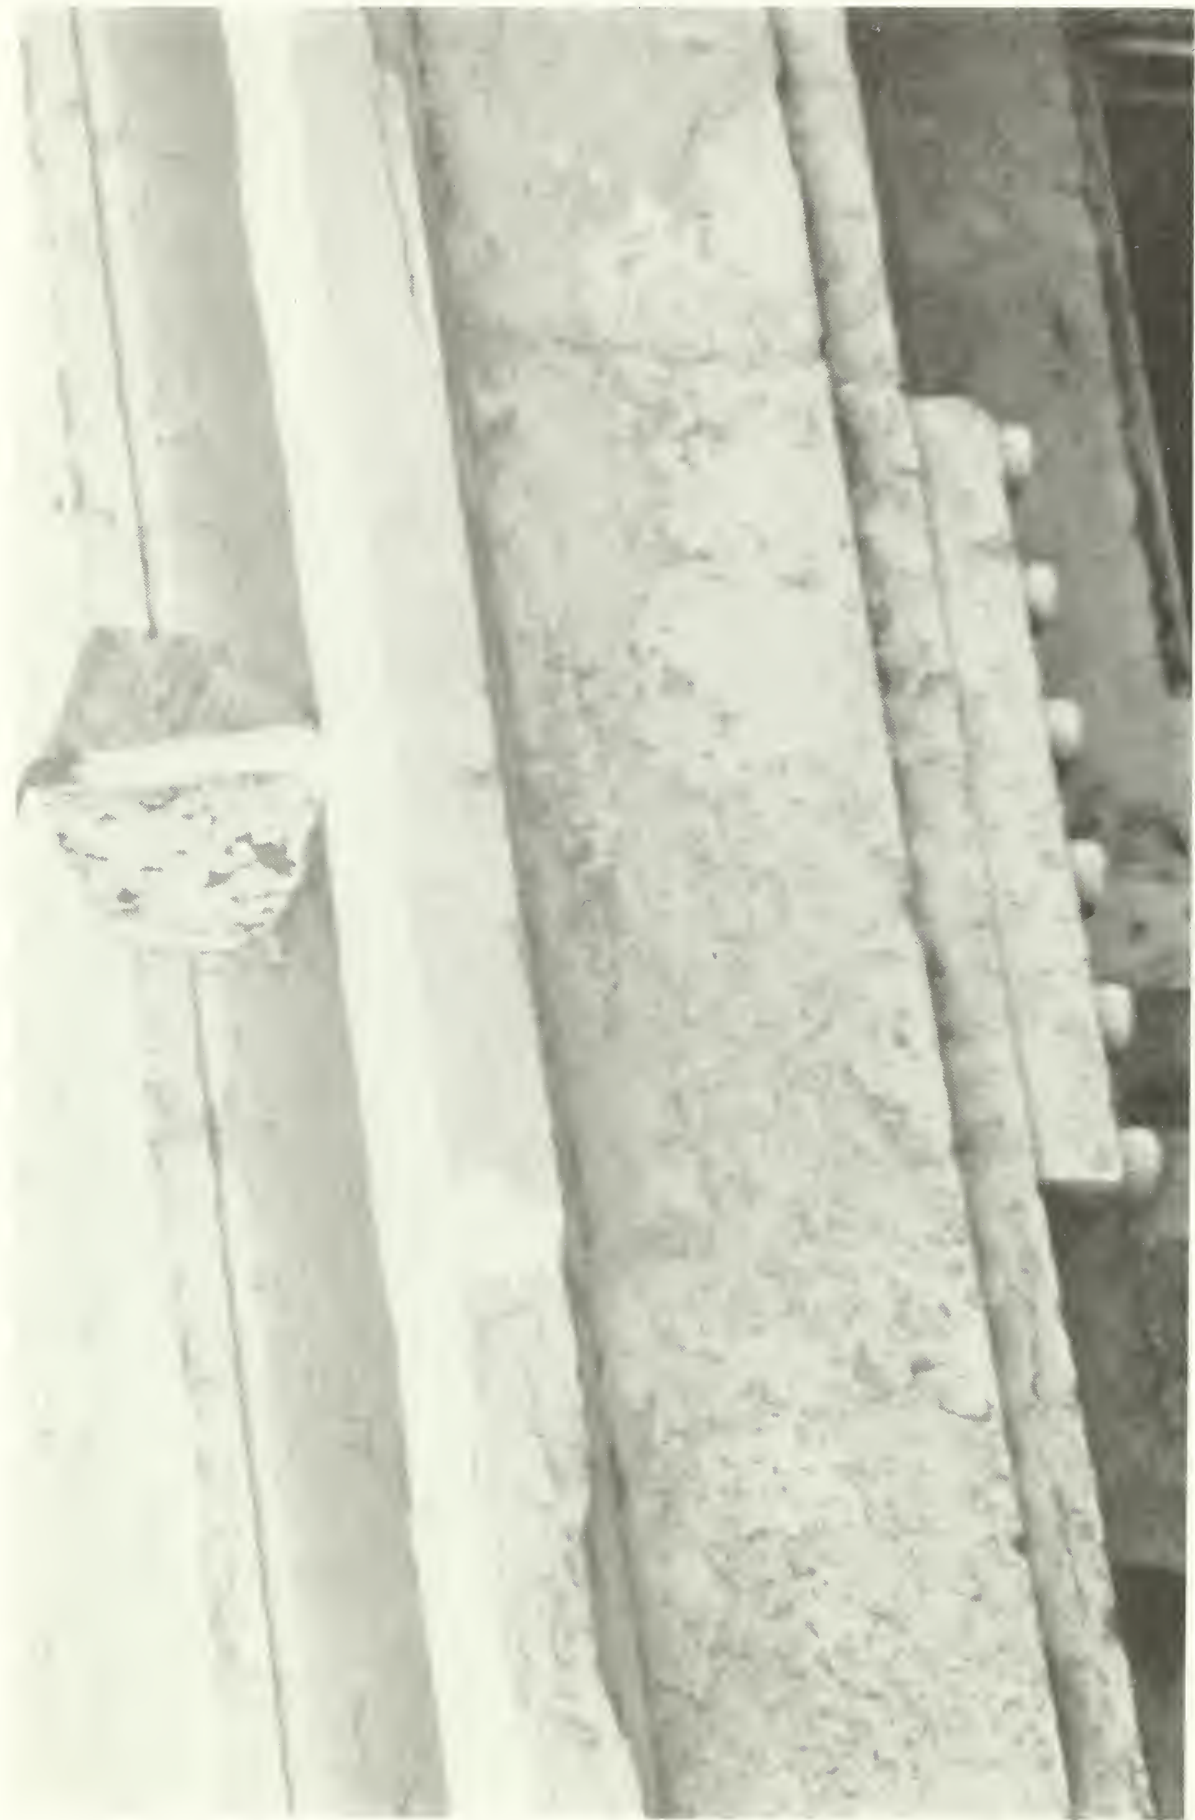
36. Cornice section in relatively good condition. Note replacement stone in parapet.

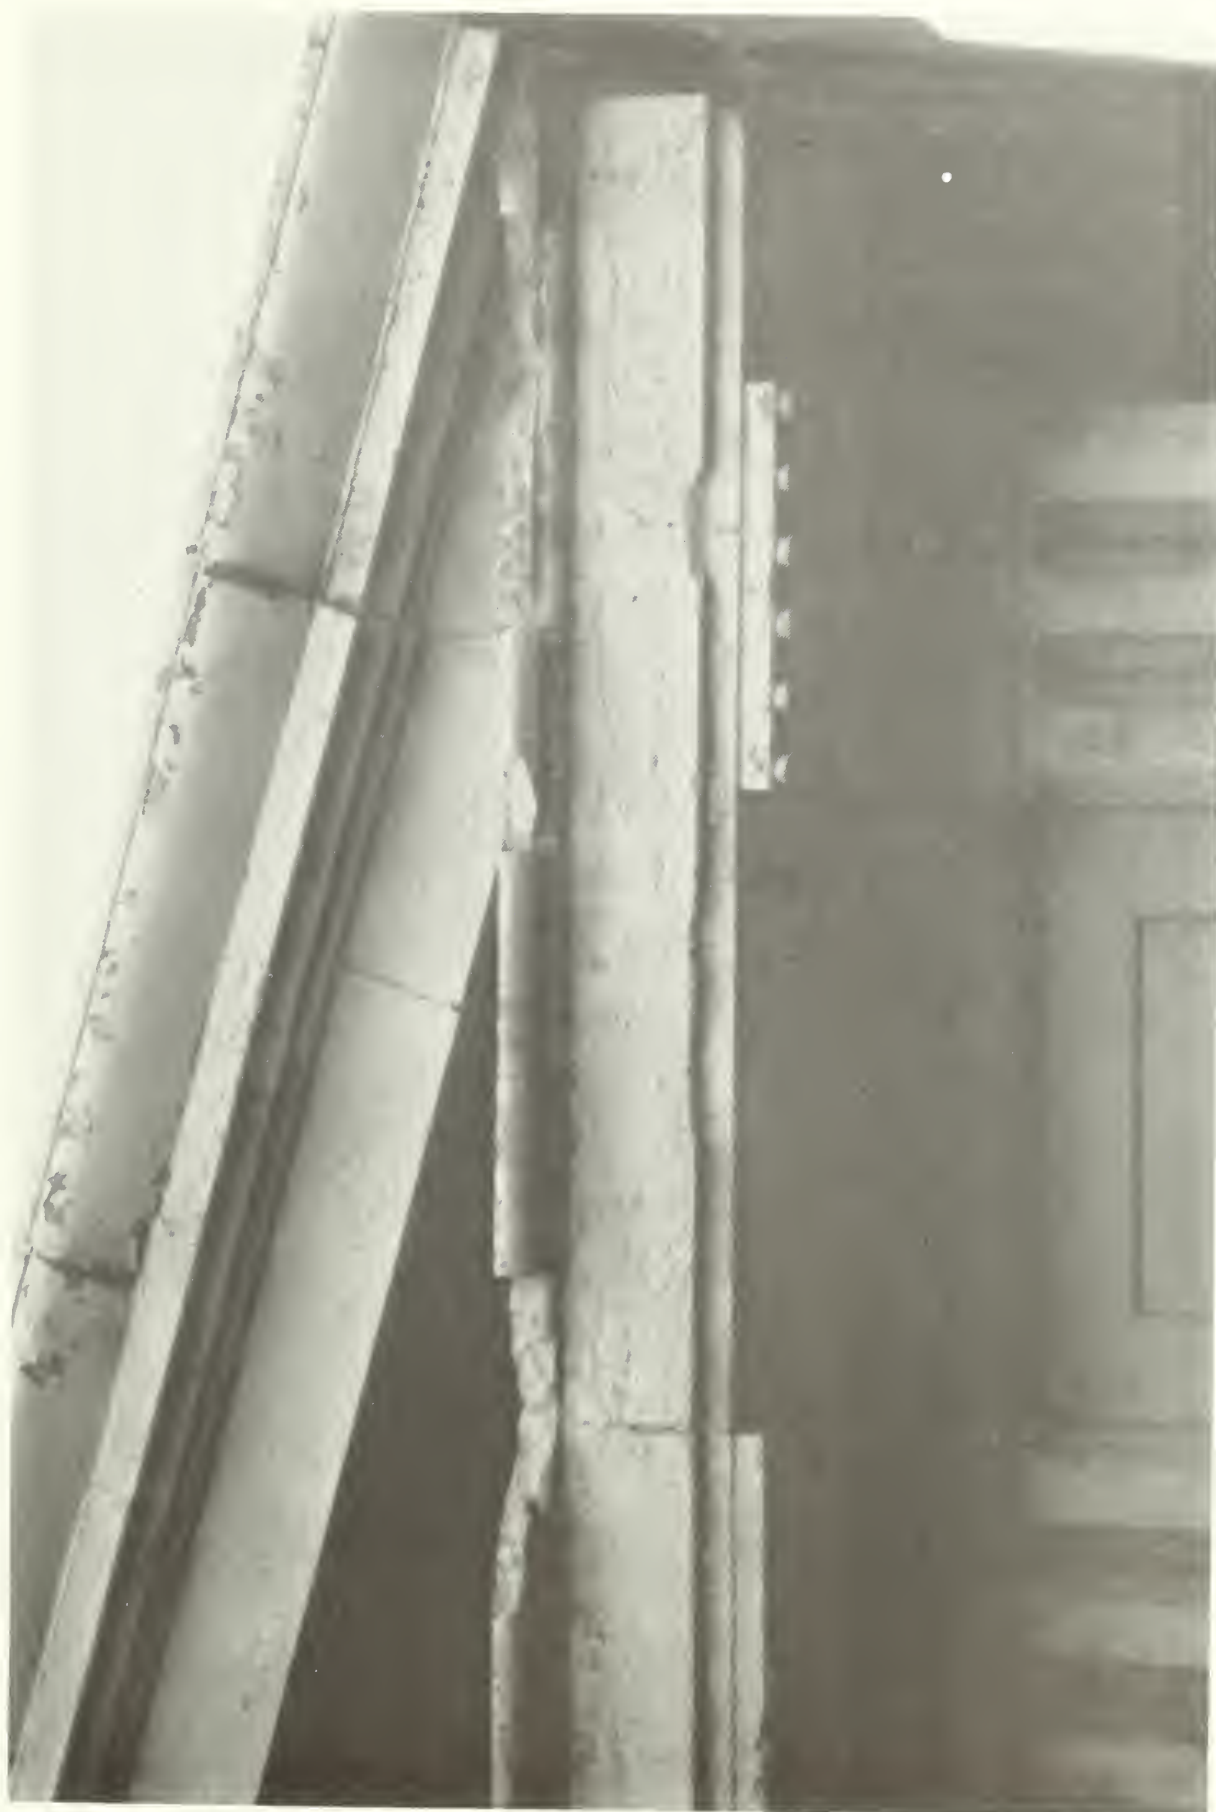
37. Typical chipped section of cornice.

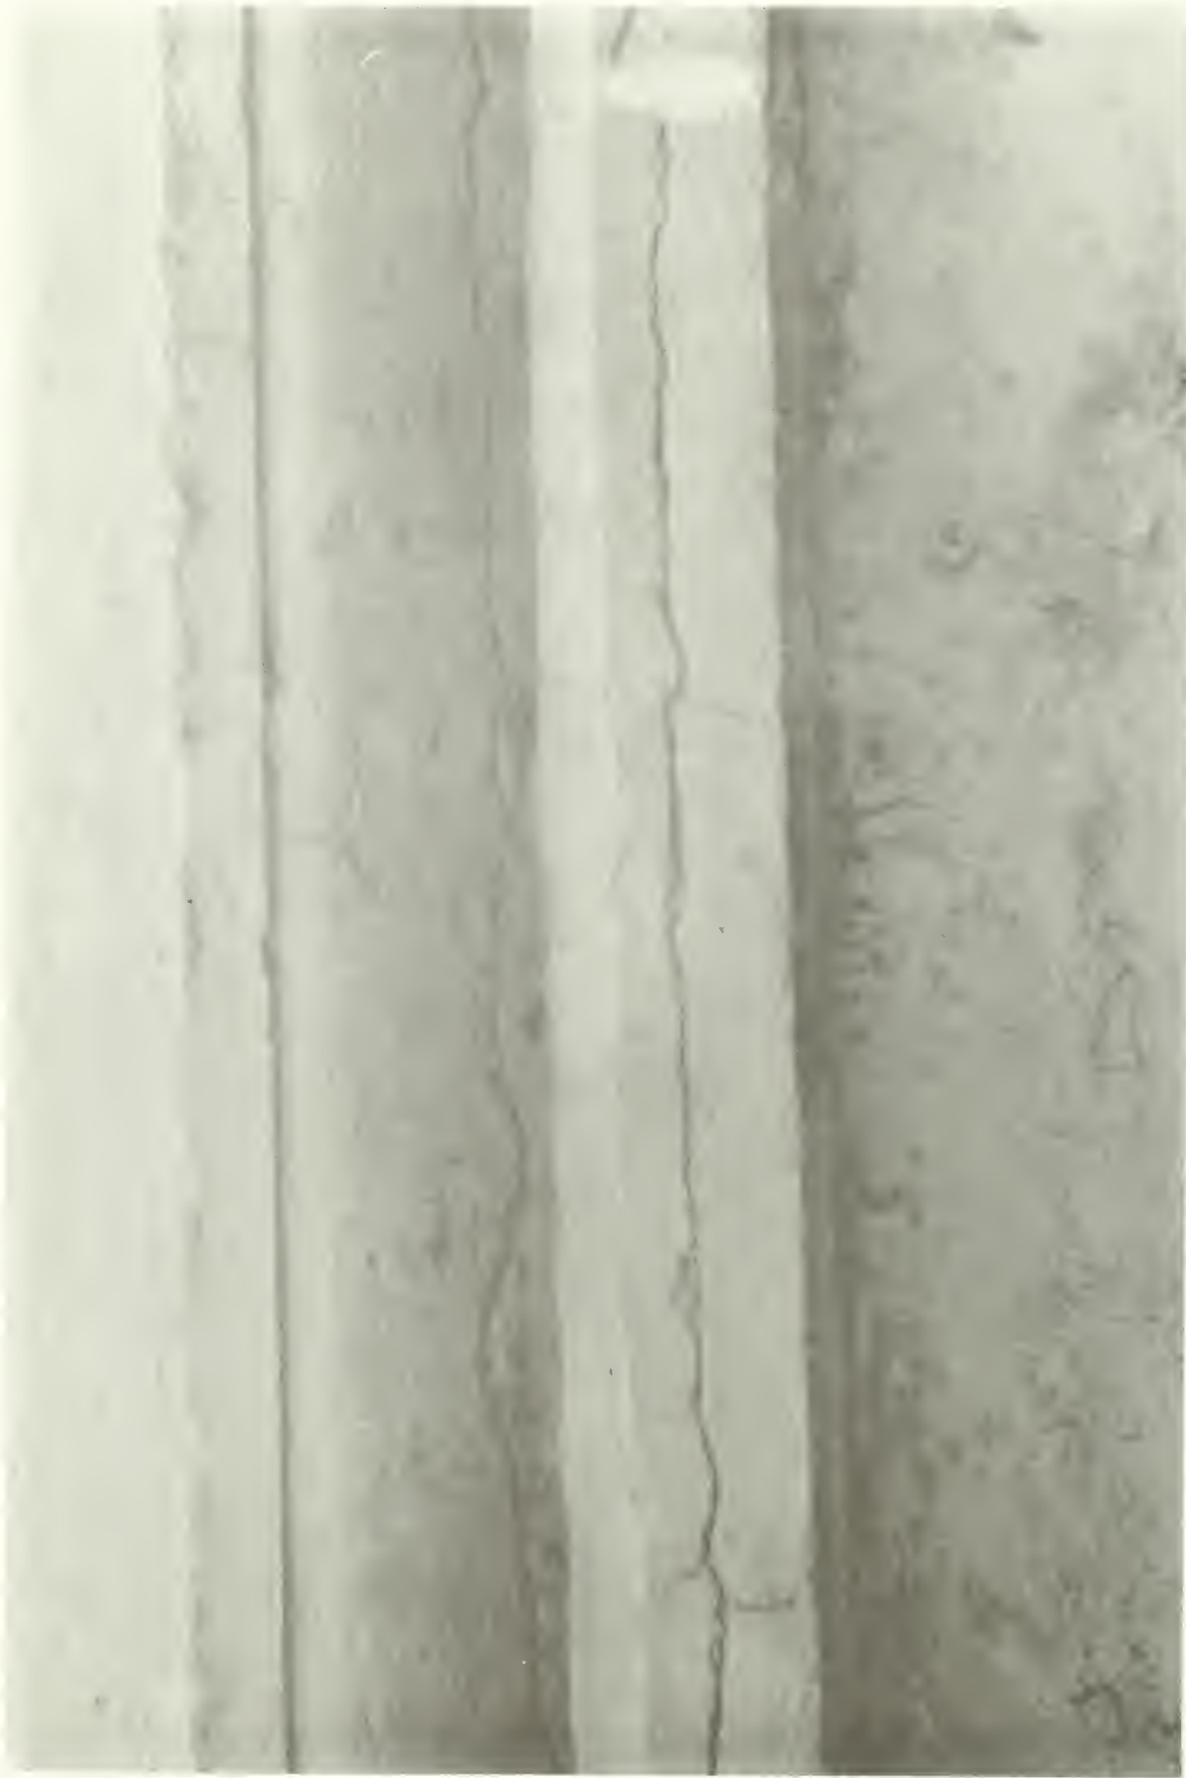
A detailed visual examination of the main cornices will be conducted when scaffolding is erected to remove paint from the walls. At this time, a more precise evaluation can be made of the spalled sections of the crown molding and of the missing guttae under the frieze (see photos 37 and 38). There are perhaps 25 small chipped sections (under 12") and 10 larger ones (12" to 24"). Given the basic composition of the stone and the doubtful quality control during the haphazard construction of the building, minor defects should be accepted as wear and tear and left as is; larger defects will require corrective action.

38. Typical cornice spalling.

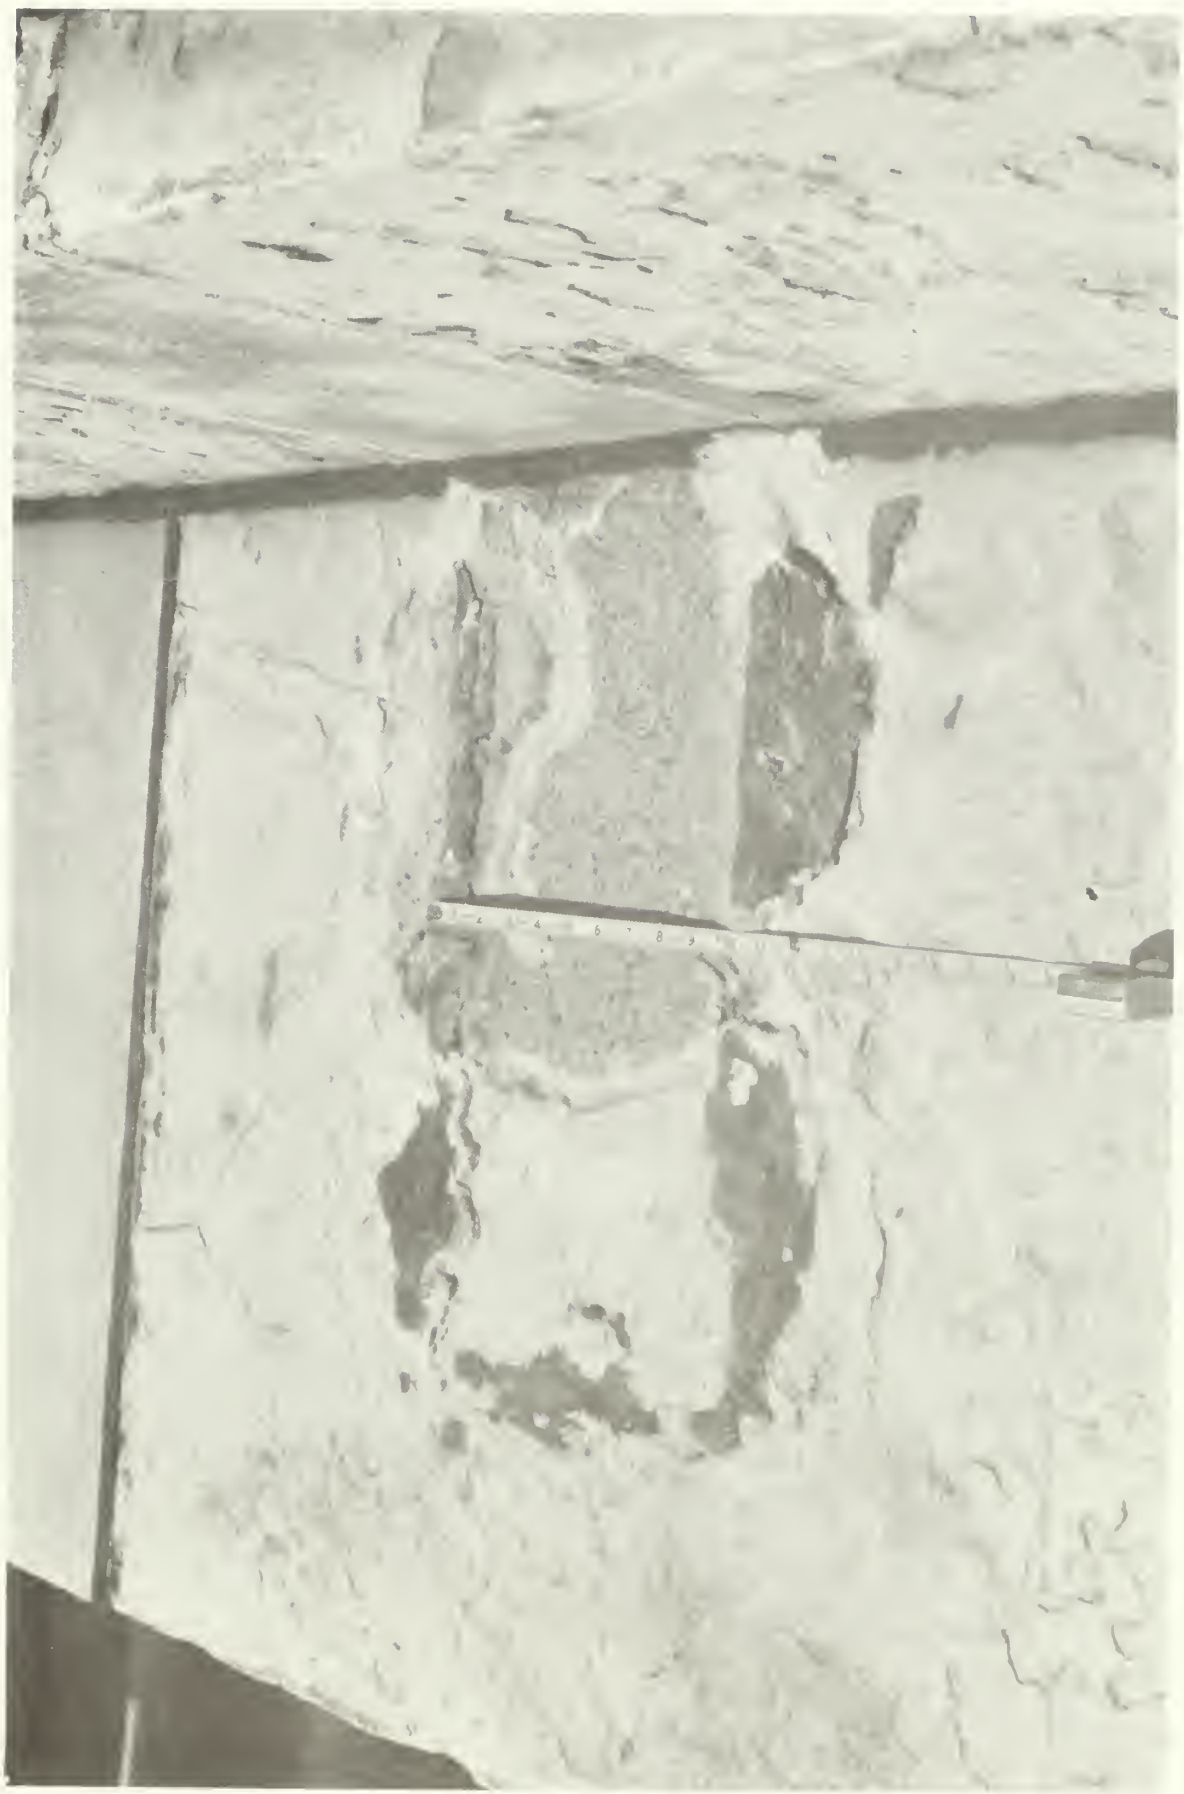
The lowest of the three stone courses comprising the cornice must be carefully inspected to determine the direction and condition of these stylolite joints. When they run parallel to the wall surface, the projecting portion of the stone runs a high risk of separation. This weak joint is treated to the full weight of the cantilevered portion of the stone and the two courses above it. Since the cornice is covered with up to 18 layers of paint, these features are currently difficult to impossible to detect until the surface is cleaned.

39. Typical fissures or stylolites at main cornice.

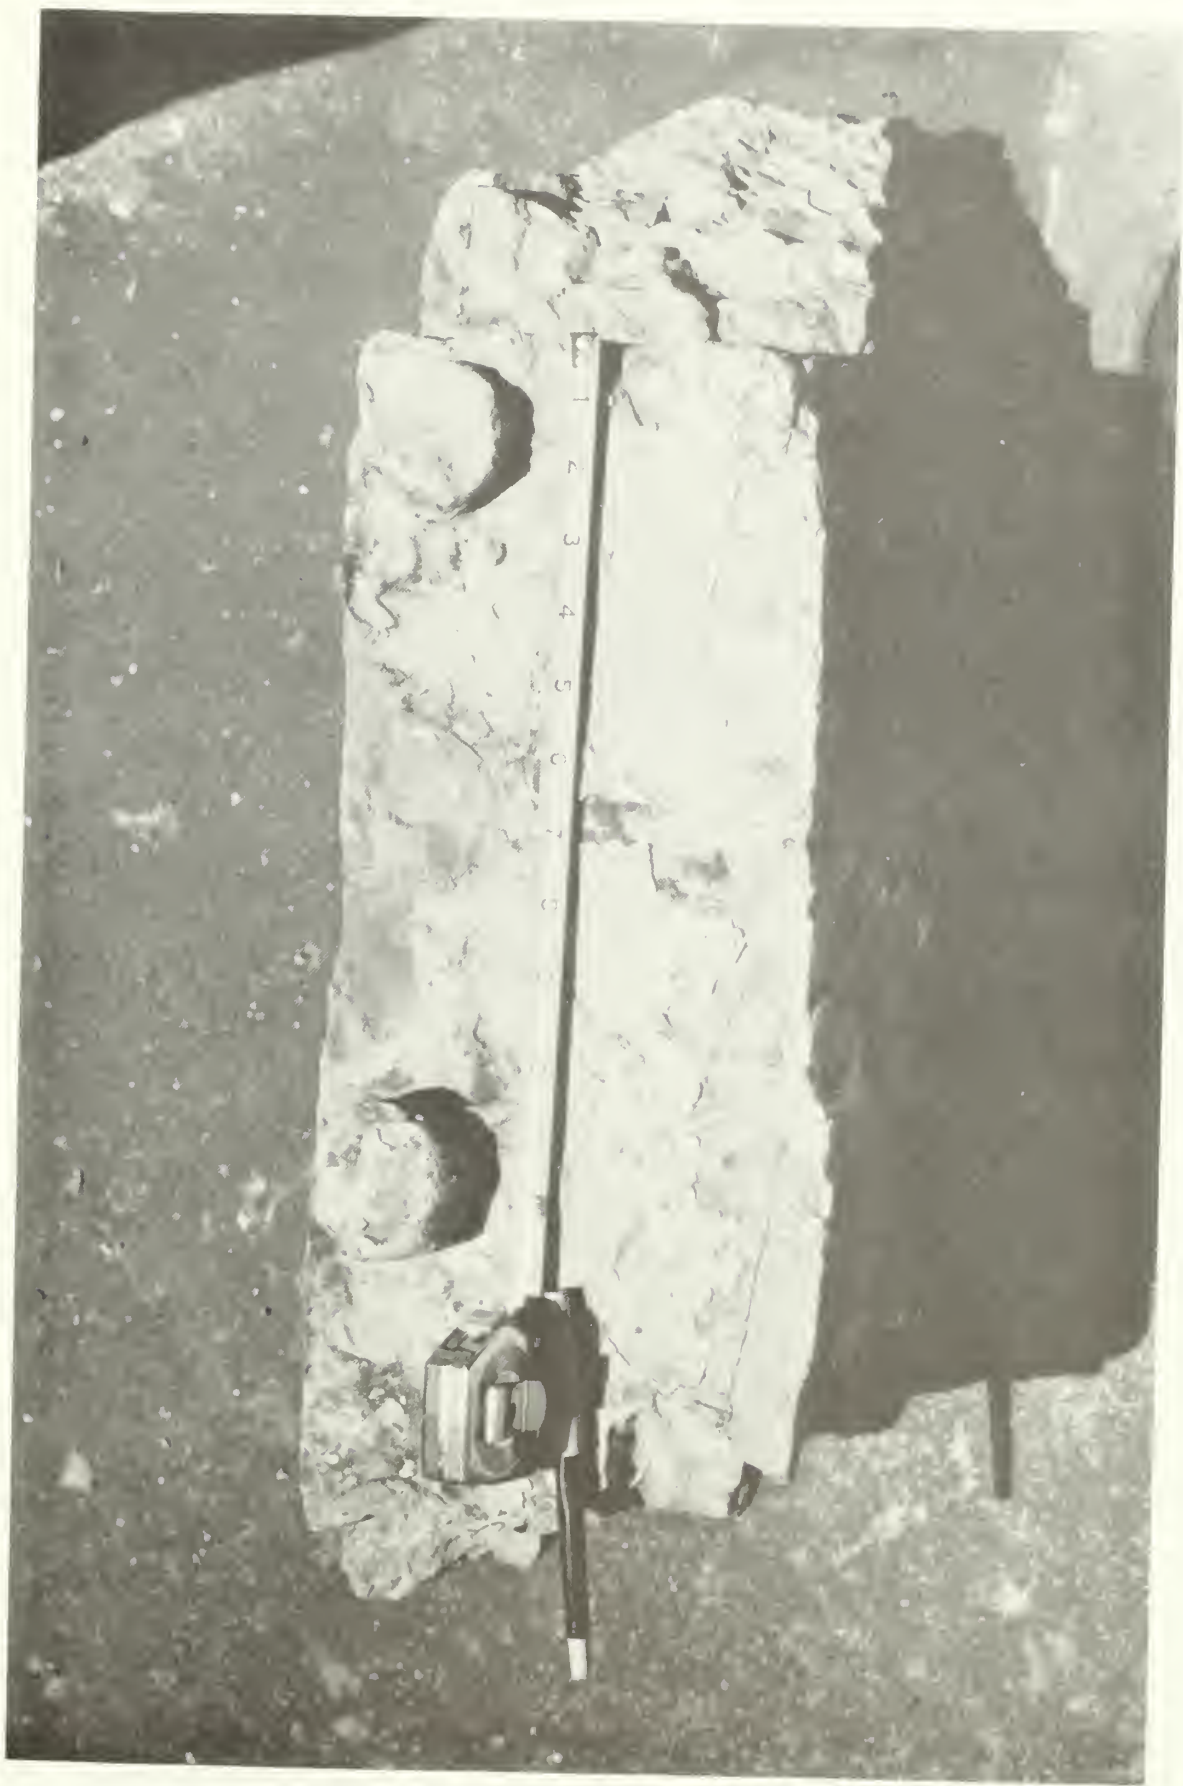
41. Missing section of cornice, north side of east wing near portico.

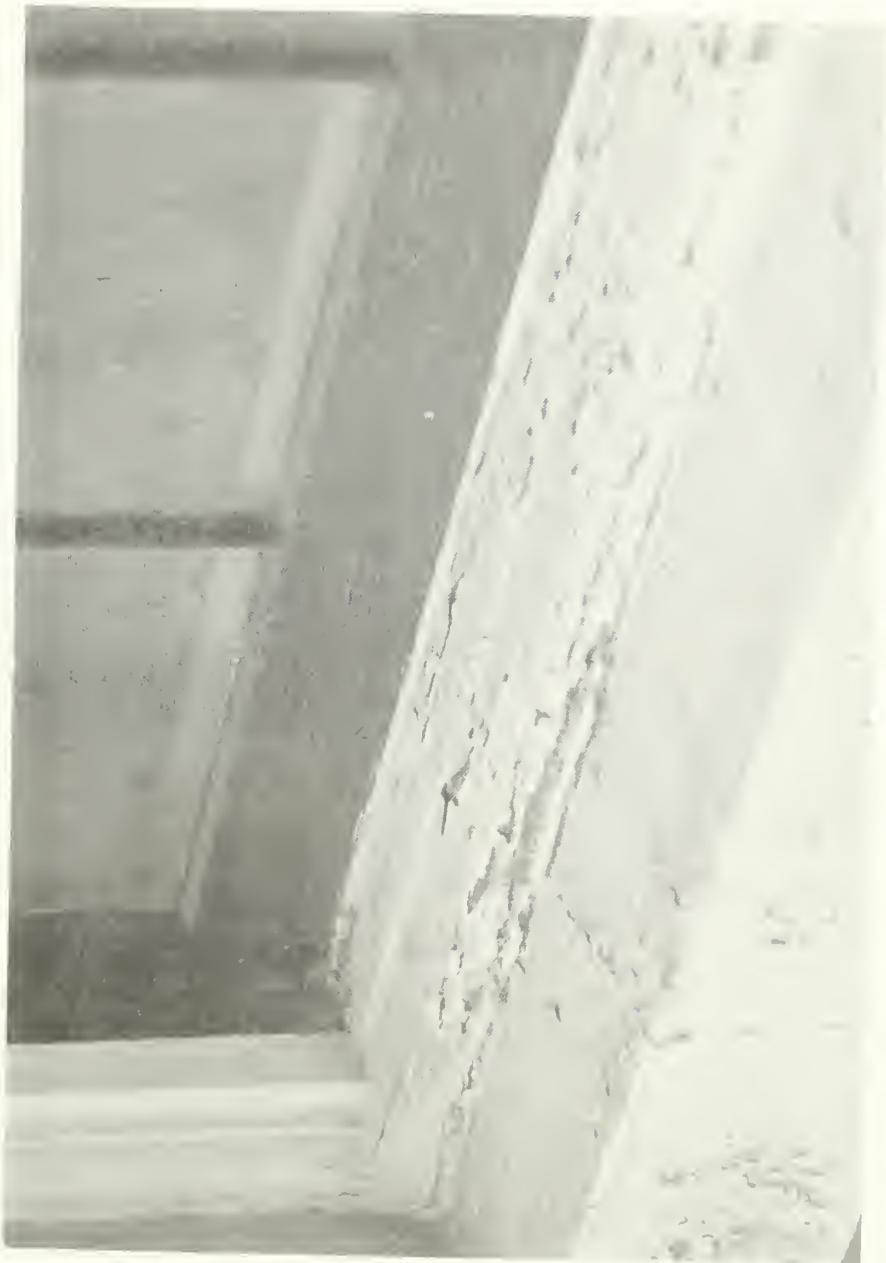
45. Typical deterioration at lower portion of basement doors and jamb.
